**APPENDIX CR-1**  
**BUILT ENVIRONMENT INVENTORY AND EVALUATION REPORT**  
**FEBRUARY 2024**

**Built Environment Inventory and  
Evaluation Report  
for the  
Coyote Creek Agrivoltaic Ranch Project**

**Sacramento County, California**

**February 2024**

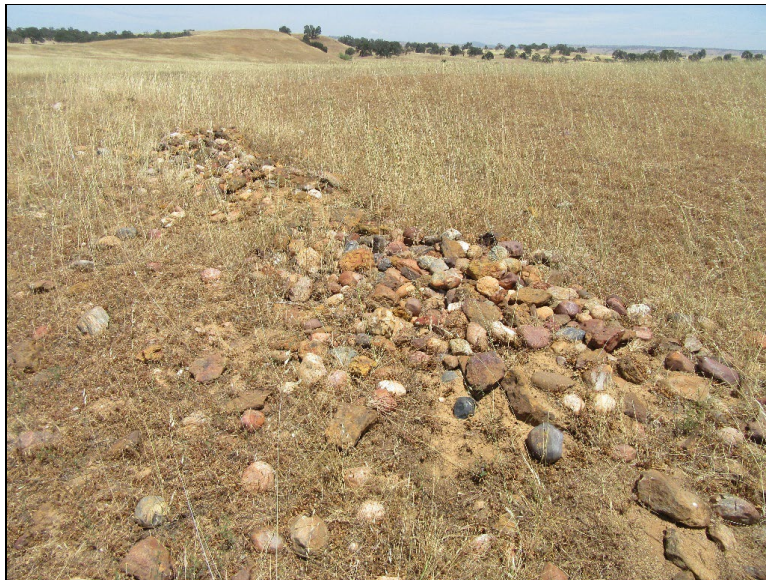
During ECORP's 2022 field inspection, the resource was revisited and appeared to be in similar condition as originally recorded. During the field inspection, the resource location was updated and corrected to approximately 90 feet east of its originally recorded location. A small pile of cobbles was observed within an open field near the fence. No evidence of the rock wall is visible in aerial photographs, and it is not depicted on topographic maps or GLO maps. The fence is in poor condition, has long been abandoned, and no longer functions as a fence. No artifacts or fence posts were observed associated with the resource.

**Figure 4. P-34-1573. Rock wall Overview (view north; May 27, 2022).**

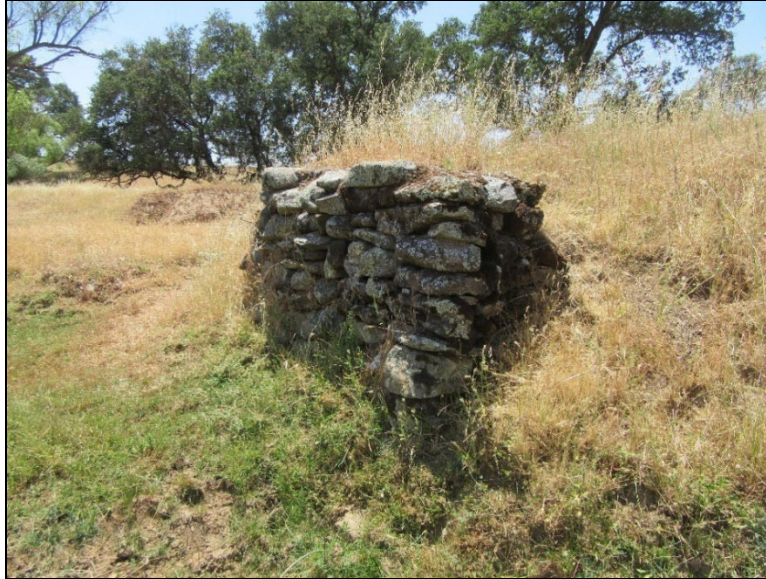
During the 2022 field inspection, the resource was located on Coyote Creek and appeared in similar condition as originally recorded. Coyote Creek was dry at the time of the field visit and the stacked rock feature was visible on the northern bank. The resource location was corrected during the field inspection, approximately 80 feet south. The abutment remains intact on the northern bank but has long been abandoned, and no longer functions as a bridge abutment. No artifacts were observed associated with the resource. No evidence of the feature is visible in aerial photographs nor is it depicted on topographic maps or GLO maps.

**Figure 5. P-34-1575. Bridge Abutment on Coyote Creek Overview (view west; May 27, 2022).**

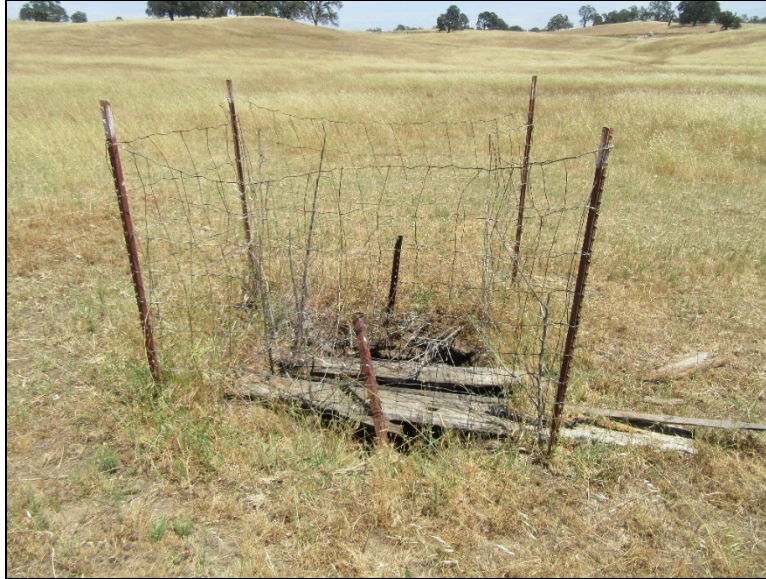
During the 2022 field inspection, the resource was located just east of Coyote Creek and appeared in similar condition as originally recorded. The well has modern fencing surrounding the open hole. The resource location was field corrected during the field inspection, approximately 130 feet southeast. The stone-lined well remains intact but appears no longer in use. No artifacts were observed associated with the resource. No evidence of the dam is depicted on topographic maps or GLO maps. An aerial photograph from 1937 faintly reveals the well.

**Figure 6. P-34-1576. Stone-Lined Well Overview (view north; May 27, 2022).**

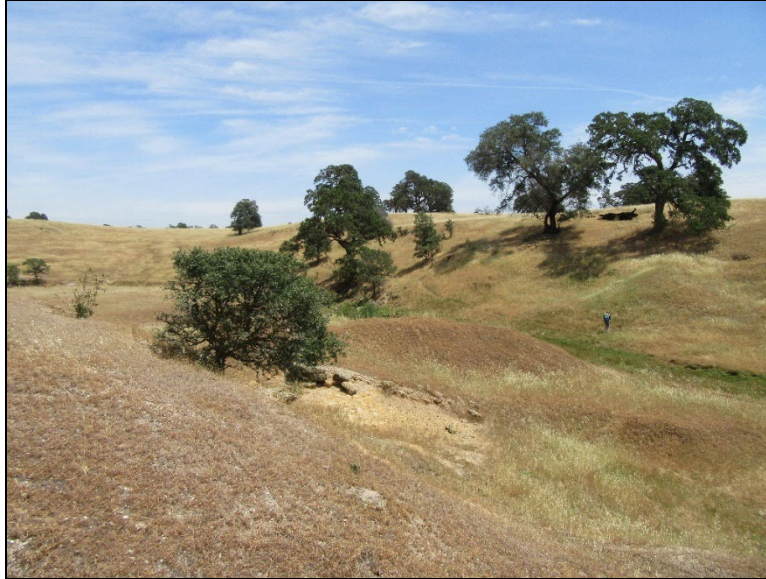
During the 2022 field inspection, the resource was revisited and found to be located on Coyote Creek. The dam appeared in similar condition as originally recorded. Coyote Creek was dry at the time of the field visit. The resource location was field corrected during the field inspection, approximately 70 feet east. No evidence of the dam is depicted on topographic maps or GLO maps. An aerial photograph from 1937 faintly reveals the mounded dirt on either side of the creek. The center of the dam is not visible on the 1937 aerial, suggesting the dam was no longer in use at that time. The center of the dam is no longer intact appears long been abandoned, and no longer functions as a dam.

**Figure 8. P-34-1577. Earthen Dam on Coyote Creek Overview (view east; May 27, 2022).**

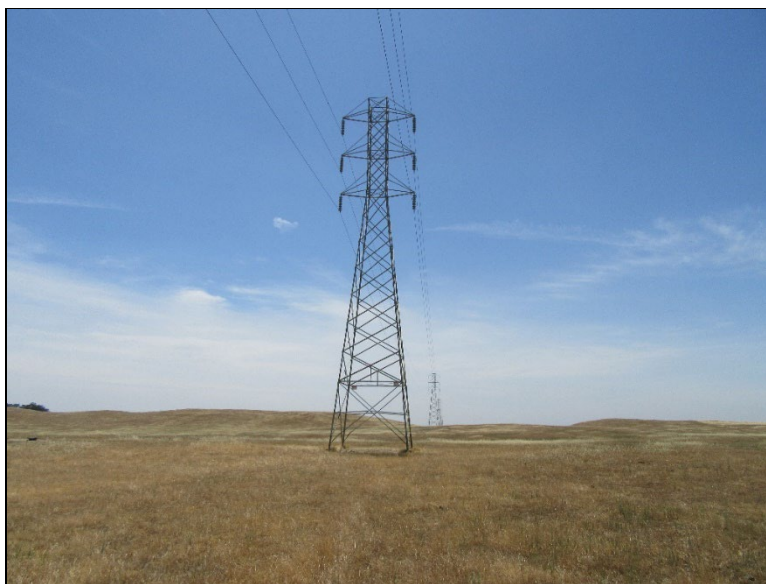
The north-south trending transmission line was revisited during ECORP's field inspection and was found to be in the same condition as previously recorded. Approximately 1 mile of transmission line and only one tower is situated in the Solar Development Area, west of Scott Road.

**Figure 10. P-34-2195; Transmission Line Overview (view south; May 27, 2022).**

Overall, the transmission lines and the steel lattice tower is in good condition and remain in their original alignment corridor. It could not be determined whether the tower for the transmission lines had been updated or altered after their original construction, but the line and tower appear in their original location. Therefore, transmission line P-34-2195 retains integrity of location, setting, feeling, and association, but the integrity of materials, workmanship, and design are uncertain. Regardless of integrity, P-34-2195 does not qualify for inclusion in the NRHP or CRHR as an individual resource due to lack of significance.

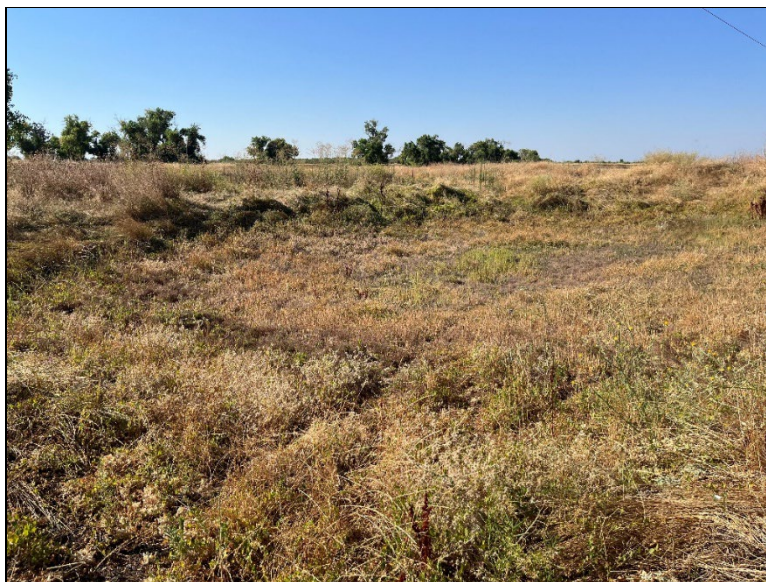
JRP Historical Consulting, LLC previously recorded Resource P-34-5261/CA-SAC-1255H in 2019 as a dam and reservoir. The dam is a 4-foot-tall and 325-foot-long earthen dam that impounds water in a 0.07-acre pond. The berm measures 8 feet wide at its base and 3 feet wide at its crown. During ECORP's 2023 field inspection, the resource was revisited and appeared to be in similar condition as originally recorded.

**Figure 12. P-34-5261. Dam and Reservoir Overview (view southwest; August 4, 2023).**

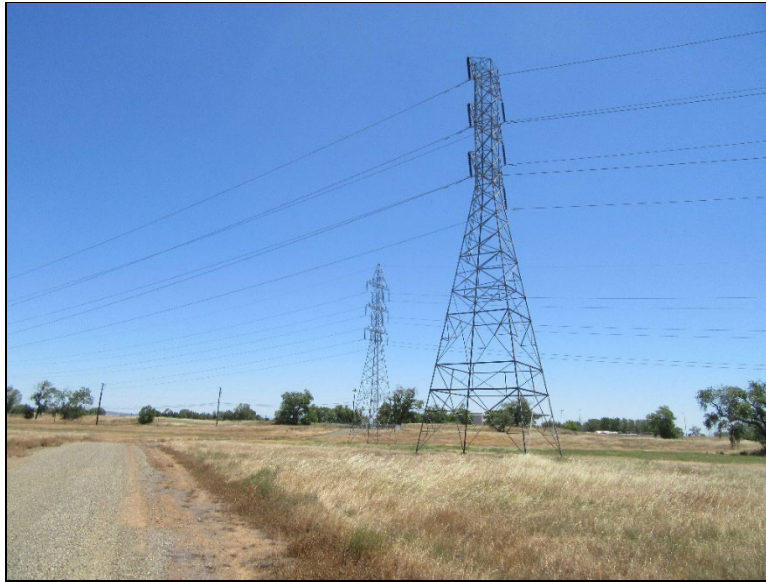
The parallel transmission lines were revisited during ECORP's field inspection and were found to be in the same condition as previously recorded. The transmission lines are located within the proposed gen-tie line

and approximately 200 feet of the line is present in the Solar Development Area, containing one tower of P-34-5268 and the overhead lines of P-34-5268.

**Figure 13. P-34-5267 and -5268; Transmission Line Overview (view east; May 27, 2022).**

The transmission lines and steel lattice towers are in overall good condition and remain in their original alignment corridor. It could not be determined whether the towers for the transmission lines had been updated or altered since their original construction, but the line and towers appear in their original location. Therefore, the transmission lines, previously recorded as P-34-5267 and -5268, retain integrity of location, setting, feeling, and association, but the integrity of materials, workmanship, and design are uncertain. Regardless of integrity, P-34-5267 and -5268 do not qualify for inclusion in the NRHP or CRHR as individual resources due to lack of significance.

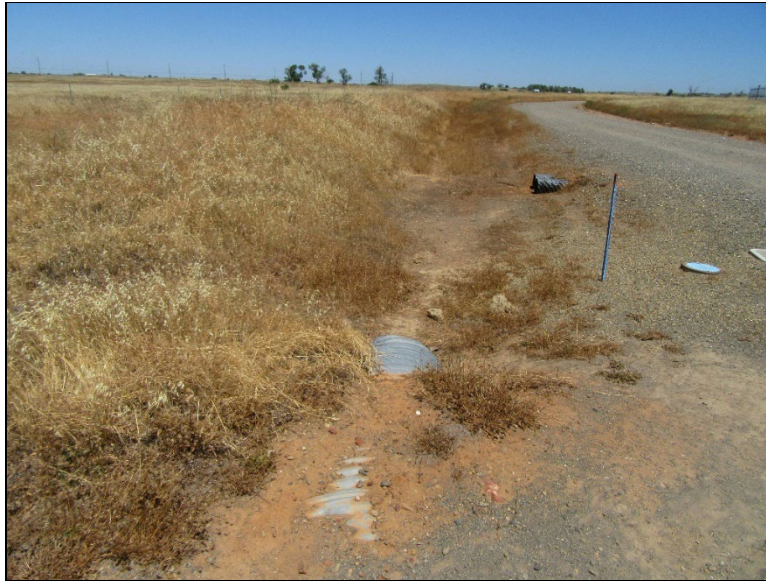
A 720-foot segment of the previously recorded ditch was found located within the Solar Development Area during ECORP's 2022 field inspection and is visible on the 1952 aerials. The entire length of the ditch was not revisited, only the 720-foot segment. The ditch appeared in similar condition as originally recorded. At the revisited segment, a modern gravel access road has been built through and east of the ditch. Modern culverts were observed at the access road crossings.

**Figure 14. P-34-5265 Ditch Overview (view north; May 27, 2022).**

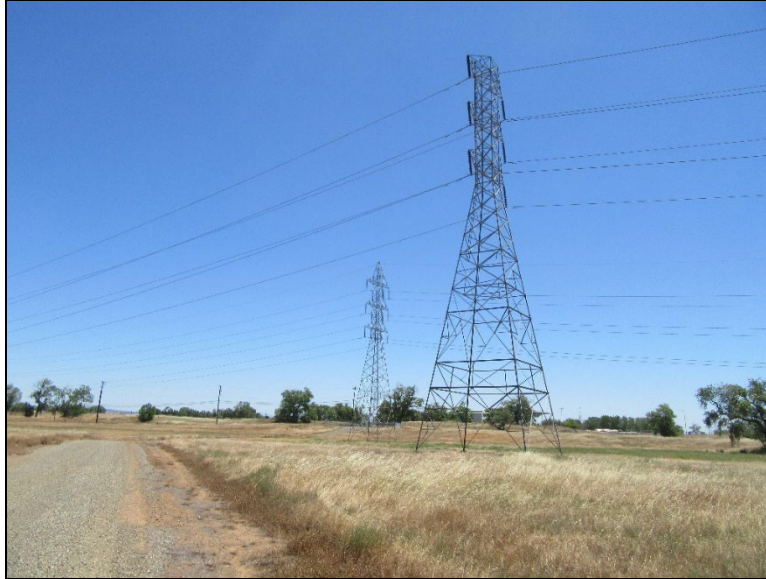
The parallel northeast-to-southwest trending transmission lines were revisited during ECORP's field inspection and were found to be the same as previously recorded. The transmission lines are located within the narrow proposed gen-tie line and approximately 200 feet of the line is present in the Solar Development Area, containing one tower of P-34-5268 and the overhead lines of P-34-5268.

**Figure 15. P-34-5267 and -5268; Transmission Line Overview (view east; May 27, 2022).**

The transmission lines and steel lattice towers are in overall good condition and remain in their original alignment corridor. It could not be determined whether the towers for the transmission lines had been updated or altered since their original construction, but the line and towers appear in their original location. Therefore, the transmission lines, previously recorded as P-34-5267 and -5268, retain integrity of location, setting, feeling, and association, but their integrity of materials, workmanship, and design are uncertain. Regardless of integrity, P-34-5267 and -5268 do not qualify for inclusion in the NRHP or CRHR as individual resources due to lack of significance.

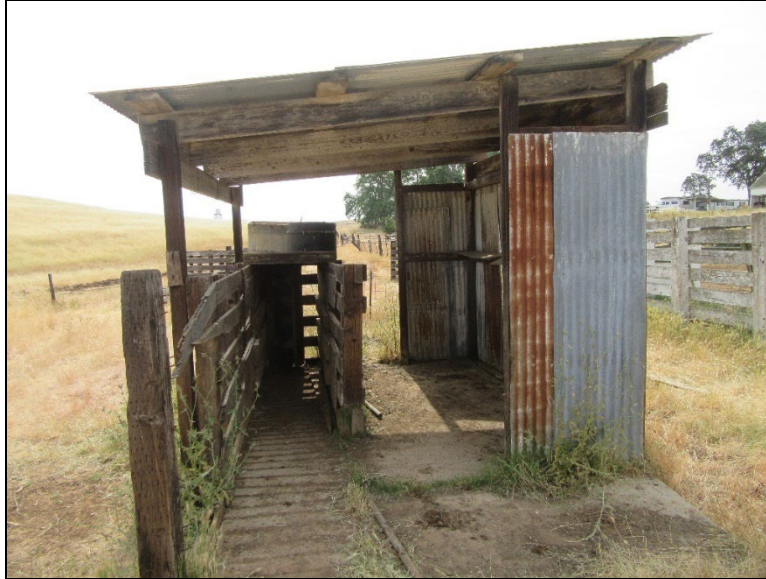
The bovine vaccination shed is a wood-frame building located immediately west/northwest of the barn. Rectangular in plan, the building has a shed roof with metal roofing. The south elevation is clad in metal siding and sits on a concrete slab foundation; elsewhere the building is open.

**Figure 27. CC-01; Bovine Vaccination Shed (view east; May 27, 2022).**

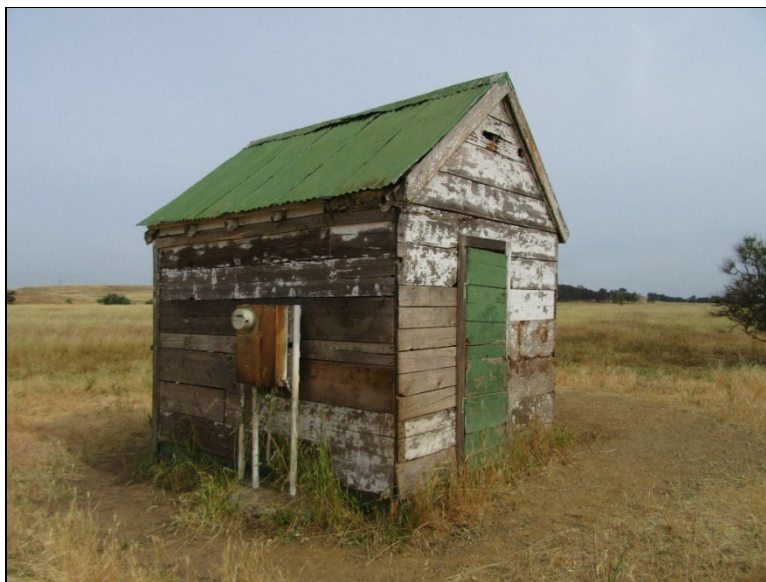
The well house is a one-story wood-frame building located 600 feet west of the barn. Rectangular in plan, the building has a front-gabled roof with metal roofing, a gable vent, and exposed rafter tails. The building is clad in horizontal wood siding and sits on a concrete perimeter foundation. Fenestration consists of a single fixed window. The building is accessed by a single-leaf man door.

**Figure 28. CC-01; Well House (view northwest; May 27, 2022).**

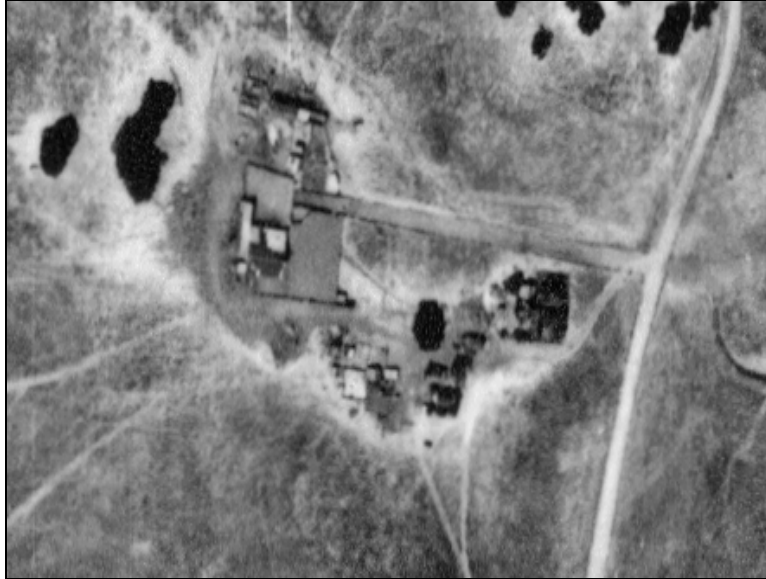
Aerial photography taken in 1937 provides the earliest depiction of the Barton Ranch Headquarters district. The image depicts the main house fronting Scott Road to the east, a central oak tree, a barn and corral to the west, and a variety of buildings and structures immediately south of the oak tree and north of the barn.

**Figure 35. The Barton Ranch Headquarters (CC-01) in 1937.**

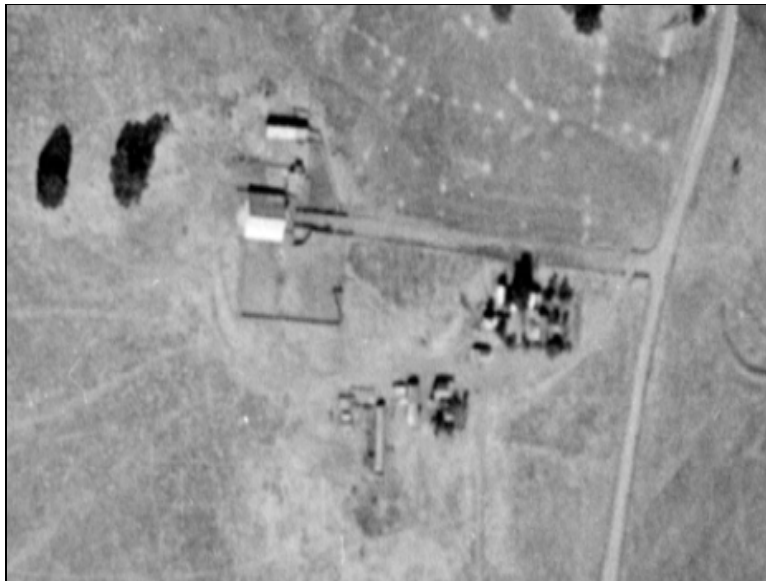
Aerial photography taken in 1952 reveals several changes, including a new barn (but same corral), the removal of the central oak tree, and the removal and replacement of several outbuildings on the south side of the property.

**Figure 36. The Barton Ranch Headquarters (CC-01) in 1952.**

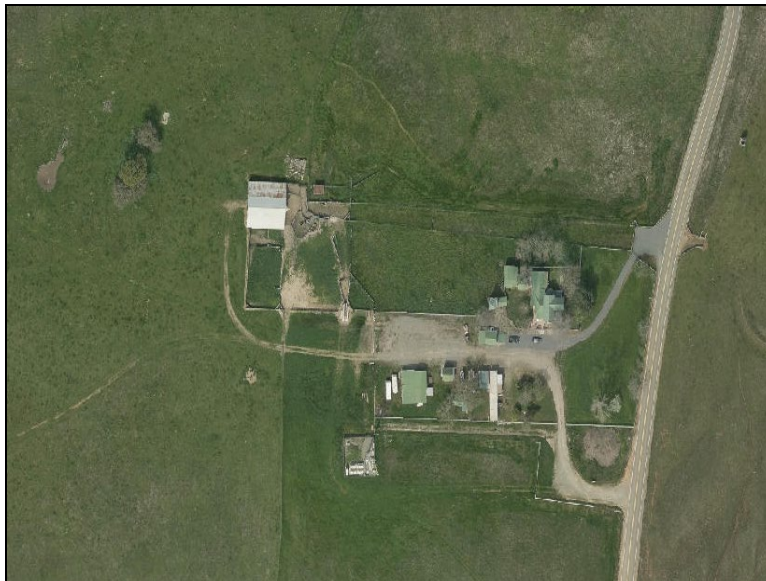
Finally, aerial photography taken in 2018 depicts the ranch headquarters' current configuration. A second drive from Scott Road was added, and the preexisting drive was straightened with a central parking area added. Outbuildings south of the drive were removed; others remained intact. The barn and corral remain intact. The main house appears substantively unchanged since the 1971 aerial photograph.

**Figure 38. The Barton Ranch Headquarters (CC-01) in 2018.**

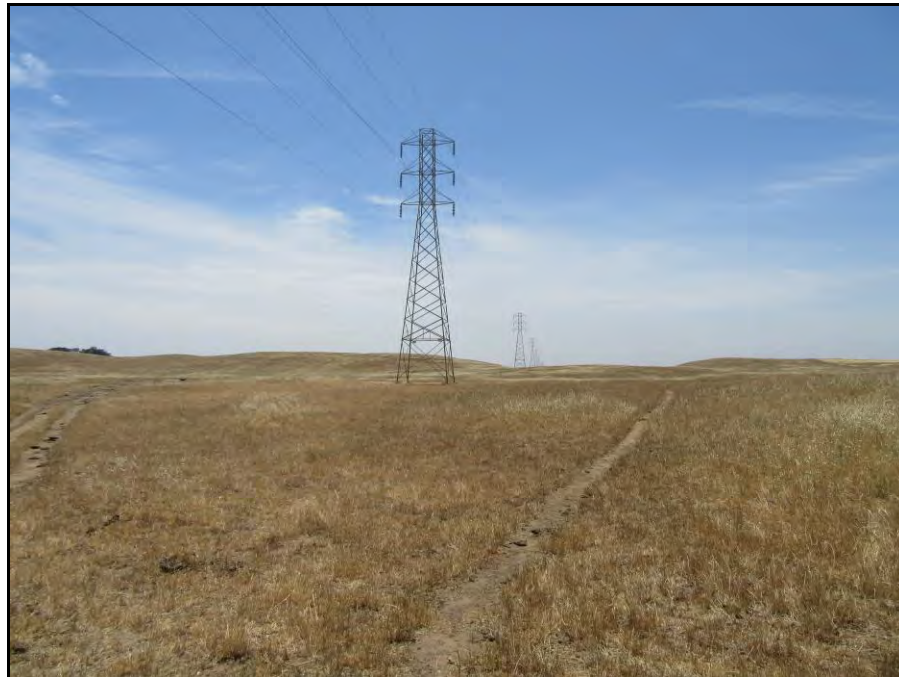
The transmission lines and seven steel lattice towers are in overall good condition and remain in their original alignment corridor. It could not be determined whether the towers for the transmission lines had been updated or altered after their original construction, but the line and towers appear in their original location. Therefore, transmission line P-34-2195 retains integrity of location, setting, feeling, and association, but their integrity of materials, workmanship, and design are uncertain. Regardless of integrity, none of the seven towers recorded during this study are eligible under any criteria to the NRHP or CRHR.

**P-34-2195; Transmission line overview (view south; May 27, 2022).**

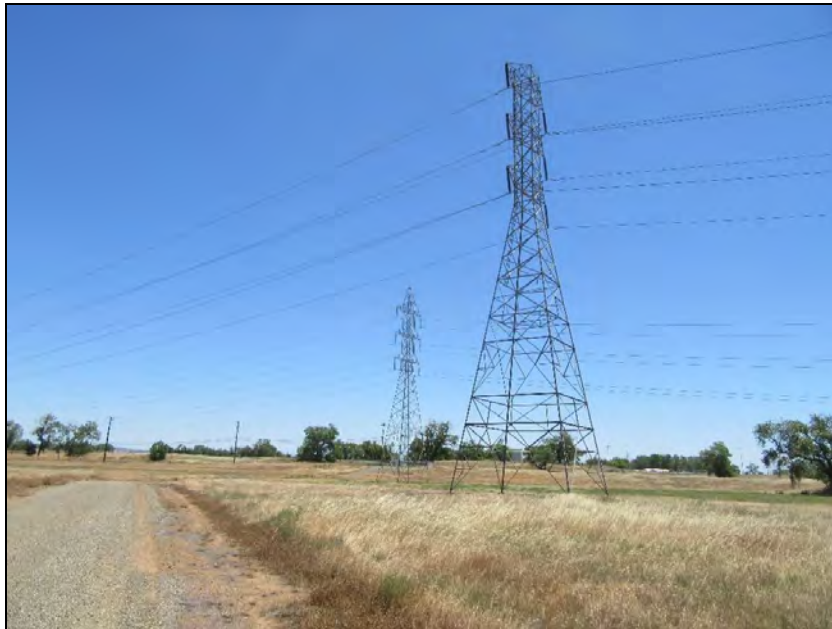
The transmission lines and steel lattice towers are in overall good condition and remain in their original alignment corridor. It could not be determined whether the towers for the transmission lines had been updated or altered since their original construction, but the line and towers appear in their original location. Therefore, the transmission lines, previously recorded as P-34-5267 and -5268, retains integrity of location, setting, feeling, and association, but their integrity of materials, workmanship, and design are uncertain. Regardless of integrity, none of the parallel and adjacent transmission lines and steel lattice towers revisited during this study are eligible under any criteria to the NRHP or CRHR.

P-34-5267 and -5268; transmission line overview (view east; May 27, 2022).
